Asbestos Management Plan

Cardinal Wiseman Catholic School

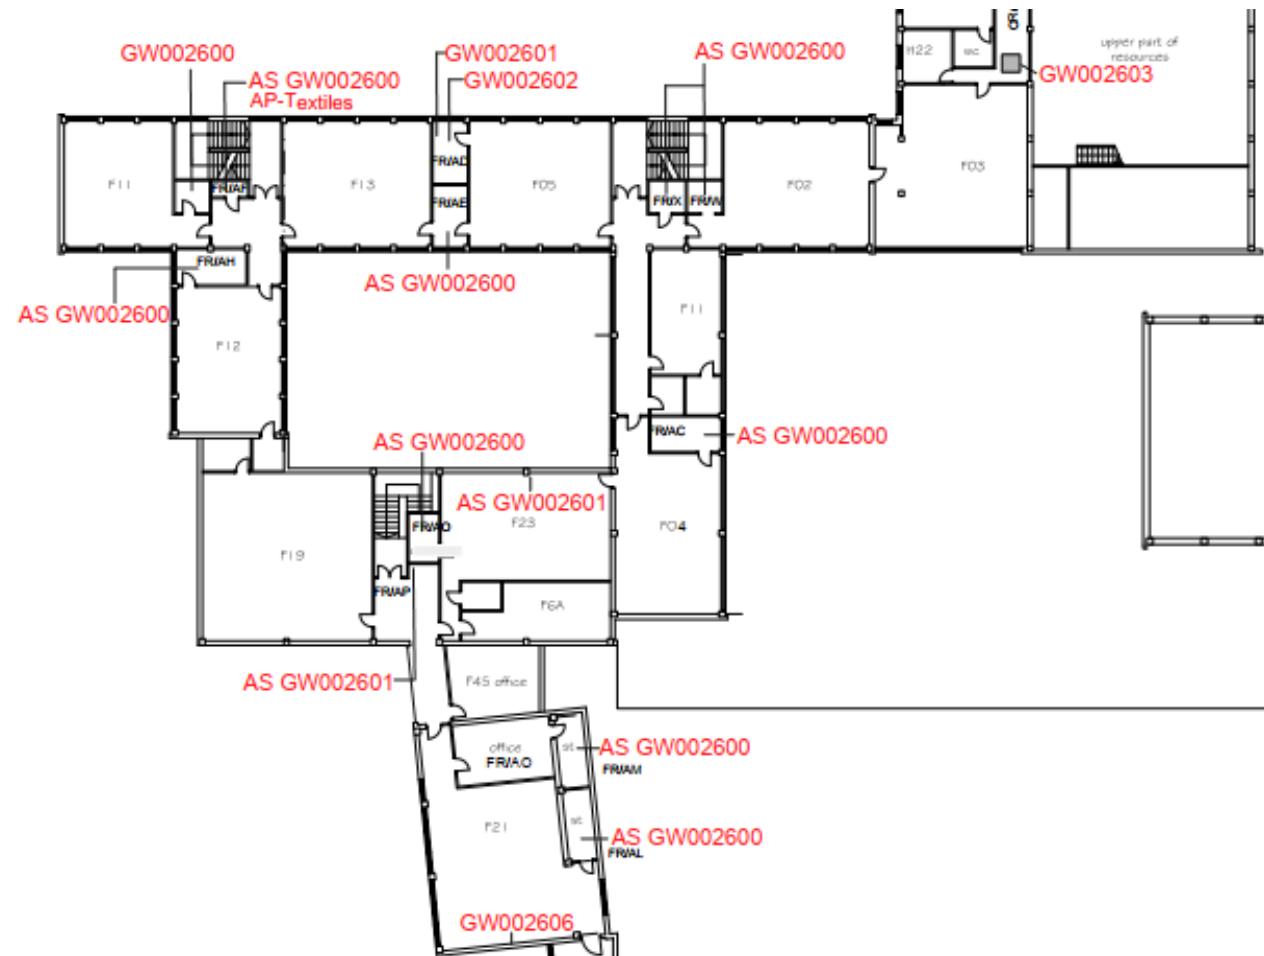
Project No	Client	Site Address	Building	Floor	Surveyor	Date
J004016	The Romero Catholic Academy	Cardinal Wiseman Secondary School, Potters Green Road, Coventry, CV2 2AJ	Main	1 st (FR)	Gary Williams	25 th Feb 2025

AP-Board to all Vertical Columns

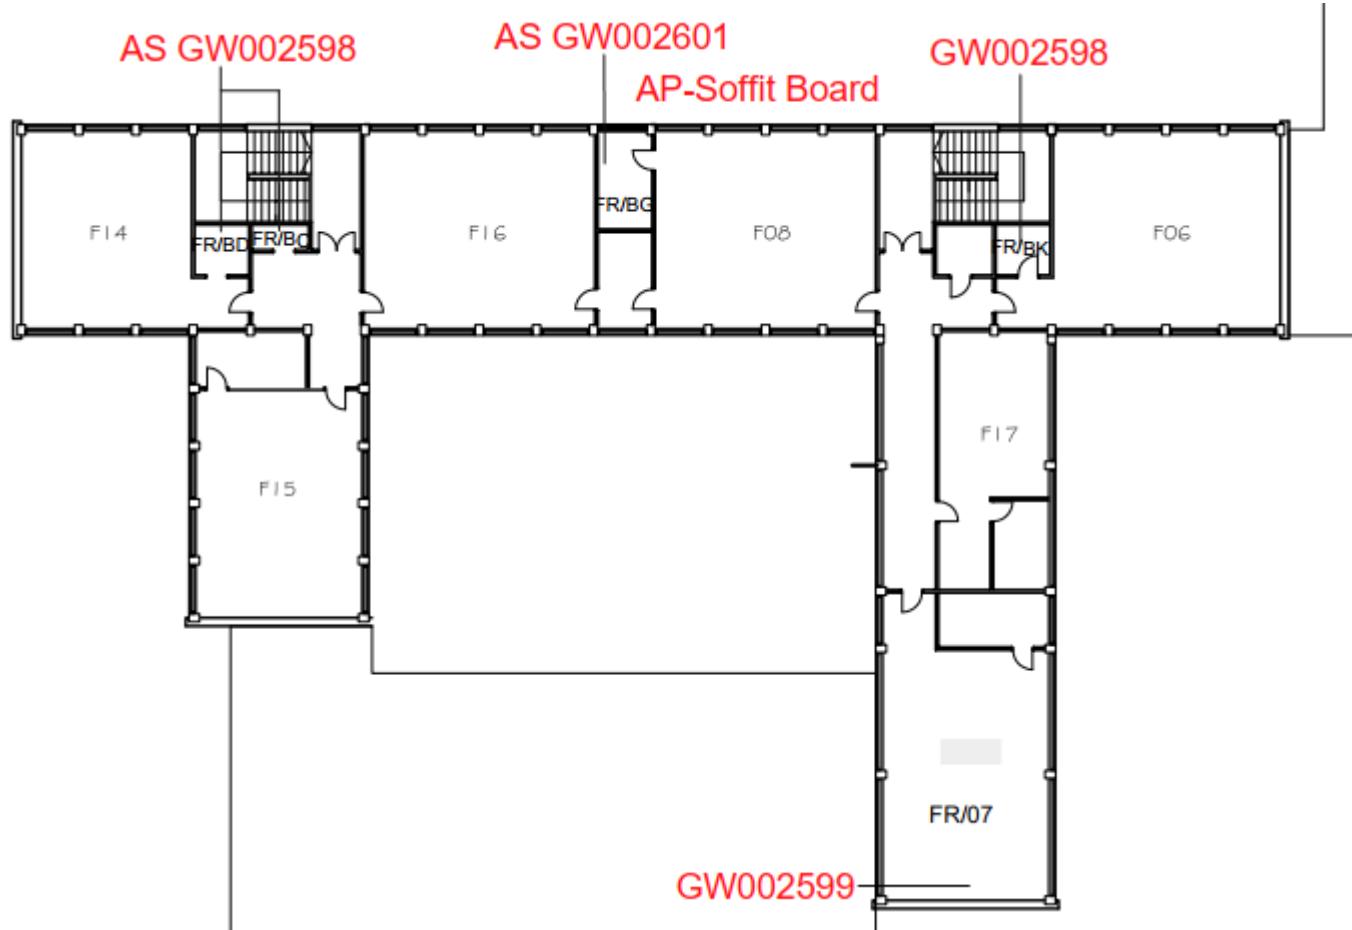
Project No	Client	Site Address	Building	Floor	Surveyor	Date
J004016	The Romero Catholic Academy	Cardinal Wiseman Secondary School, Potters Green Road, Coventry, CV2 2AJ	Main	2 nd (FR)	Gary Williams	25 th Feb 2025

AP-Board to all Vertical Columns

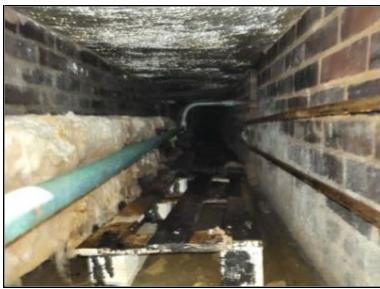
Survey Date:	Lead Surveyor	Survey Type	Floor	Analysis
	20 Nov 2023 to 21 Nov 2023	Gary Williams	Sampling Survey	Ground Floor	N/A
	Building	Room	Item	Quantity	
	Secondary school	Saint Francis corridor G01	South Direction	N/A	
	Sample No (S,SP,P,As)	Product Type	Surface Treatment	Condition	Accessibility
	Visual (P)	N/A	N/A	N/A	N/A
	Material Risk Score				
N/A					
Recommended action	No further action required				
Surveyor comments	N/A

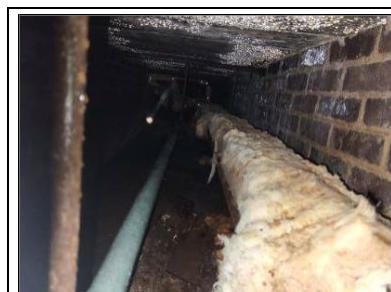
Survey Date:	Lead Surveyor	Survey Type	Floor	Analysis
20 Nov 2023 to 21 Nov 2023	Gary Williams	Sampling Survey	Ground Floor	N/A
Building	Room	Item	Quantity	
Secondary school	Saint Francis corridor G01	North Direction	N/A	
Sample No (S,SP,P,As)	Product Type	Surface Treatment	Condition	Accessibility
Visual (P)	N/A	N/A	N/A	N/A
Material Risk Score				
N/A				
Recommended action	No further action required			
Surveyor comments	N/A

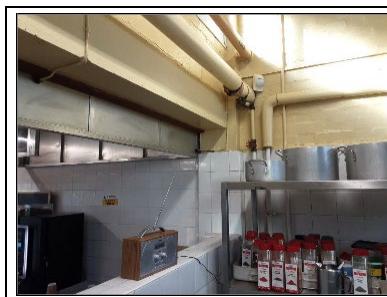
Survey Date:		Lead Surveyor	Survey Type	Floor	Analysis
4 Oct 2024		David Redfern	Refurbishment Survey	Ground Floor	No Asbestos Detected
Building		Room	Item	Quantity	
Kitchen		Kitchen G01	Mmmf To pipework	<10lm	
Sample No (S,SP,P,As)		Product Type	Surface Treatment	Condition	Accessibility
CK000560 (S)		N/A	N/A	N/A	N/A

Normal Occupancy	Score	Likelihood of disturbance	Score	Exposure Potential	Score	Maintenance Activity	Score
Main type of activity	N/A	Location	N/A	Number of occupants	N/A	Type of Maintenance	N/A
		Accessibility	N/A	Frequency of use	N/A	Frequency of maintenance	N/A
		Amount	N/A	Average Time	N/A		
Average Score	N/A	Average Score	N/A	Average Score	N/A	Average Score	N/A
Average of Priority	N/A						
Material Assessment Score	N/A						
Recommendation	No further action required
